# Manhole Inspection Summary

Manhole # S27A\_\_025MH

Insp Date: **11/28/07 1:24 PM**

**Location** Address: **701 FREMONT AVE**

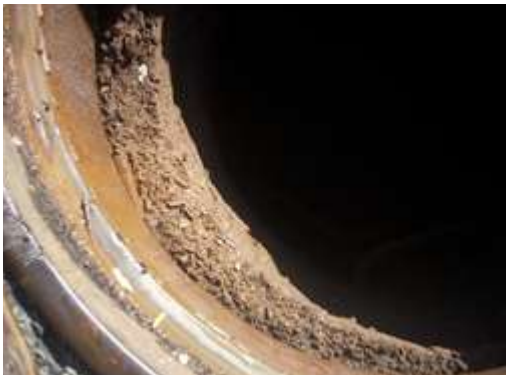
Defect 1

Offset: **3** (in.)

FRAME OFFSET

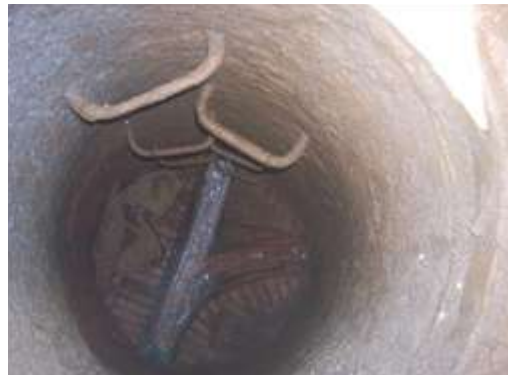
Defect 2

Count: **6** Missing: **0** ☒ **Corroded**

CORRODED STEPS

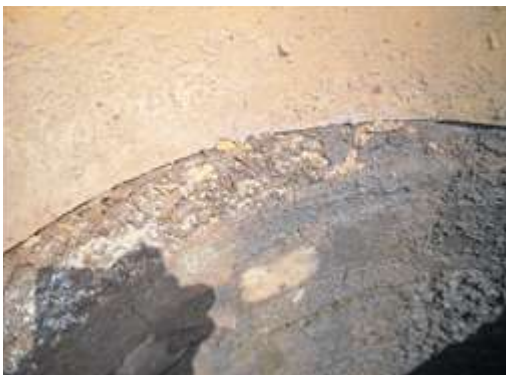
Defect 3

Comments **MUD ON WALLS, MAYBE I/I EVIDENCE - 11/28/07**  
**ADDED PHOTO SHOWING CHIMNEY DETERIORATION - 4/17/09**

Condition: ☐ Sound ☐ Cracked ☐ Root Intrusion ☐ Loose Brick ☒ **Deteriorated**

DETERIORATION OF CHIMNEY

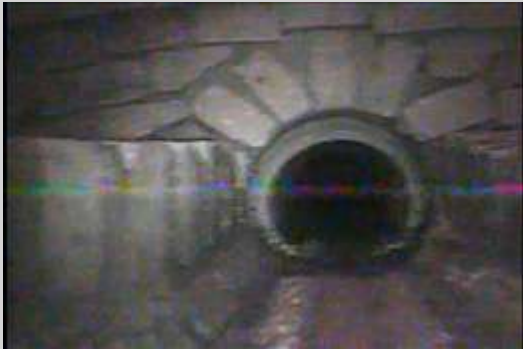
12 O'Clock Outflow

8 in. Circular Gravity Sewer  
Pipe Out @ 12 O'Clock

Pipe Height: **8.4** (in.) Rod and Bar (Angled)  
Pipe Material: **Clay** ☐ Pipe Lined  
Invert Depth: **11.04** (ft.) Flow Characteristics: **Slow**  
Deposits: ☒ None ☐ Mud ☐ Sludge ☐ Debris ☐ Grease  
Silt Depth: (in.) Deposits Extent:  
Infiltration: **None** Pipe Seal Cond: **Sound**

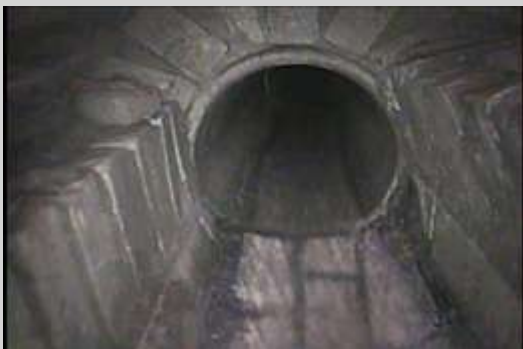
6 O'Clock Inflow

8 in. Circular Gravity Sewer  
Pipe In @ 6 O'Clock

Pipe Height: **8.4** (in.) Rod and Bar (Angled)  
Pipe Material: **Clay** ☐ Pipe Lined  
Invert Depth: **10.74** (ft.) Flow Characteristics: **Slow**  
Deposits: ☒ None ☐ Mud ☐ Sludge ☐ Debris ☐ Grease  
Silt Depth: (in.) Deposits Extent:  
Infiltration: **None** Pipe Seal Cond: **Sound**

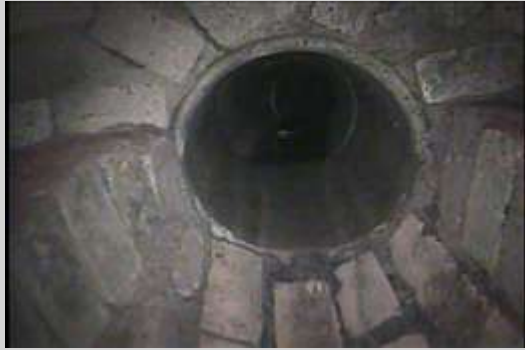
8 O'Clock Inflow

Pipe In @ 8 O'Clock

Infiltration: **None** Pipe Seal Cond: **Sound**
